HURRICANE TOMAS

DAMAGE ASSESSMENT REPORT

**Association of Professional Engineers of St. Lucia
(APESL Inc.)**

Version 1.0 - Issued December 07, 2010

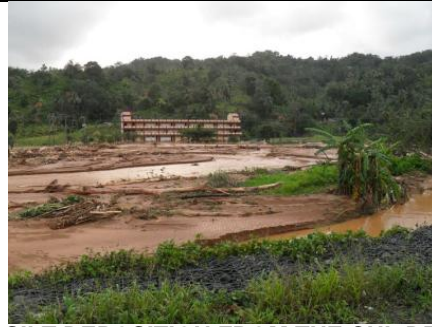
SILT DEPOSITION FROM THE CUL DE SAC RIVER IN FRONT OF THE BEXON PRIMARY SCHOOL

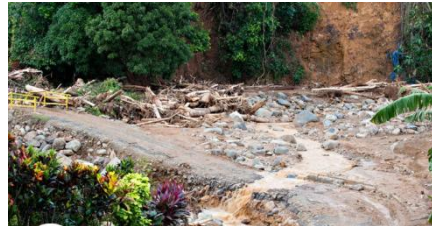
SILT AND DEBRIS DEPOSITION ALONG THE MAIN RIVER CHANNEL OF THE MARC RIVER AT MARC BRIDGE

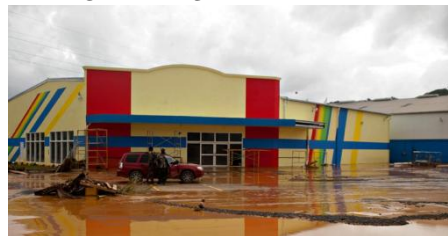
FLOODING AND SILT DEPOSITION BY THE CUL DE SAC RIVER AT CUL DE SAC INDUSTRIAL ZONE

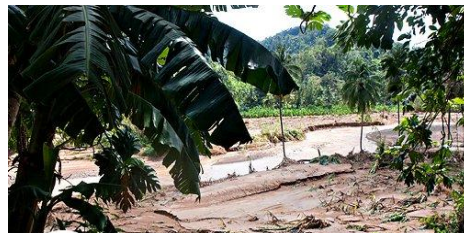
SILT DEPOSITION FROM THE ROSEAU RIVER ALONG THE CHANNEL AT VANARD

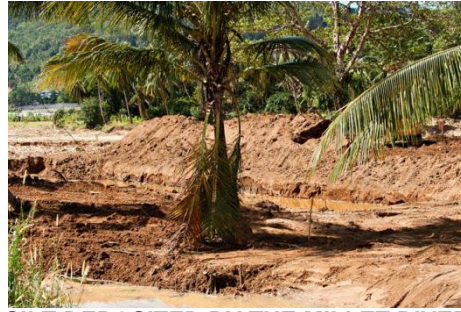
SILT DEPOSITED BY THE MILLET RIVER ALONG THE MAIN RIVER CHANNEL AT MILLET

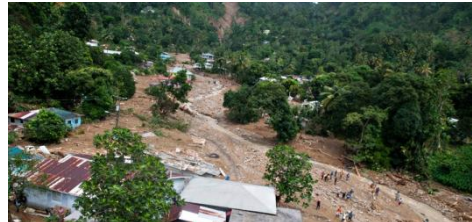
SILT DEPOSITION BY THE SOUFRIERE RIVER AT FOND ST JACQUES

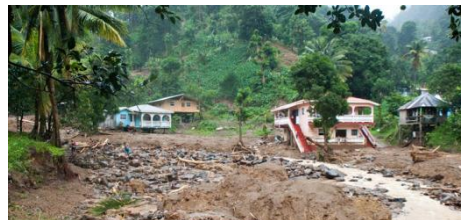
SILT AND DEBRIS DEPOSITION BY THE SOUFRIERE RIVER ALONG MAIN CHANNEL AT FOND ST JACQUES

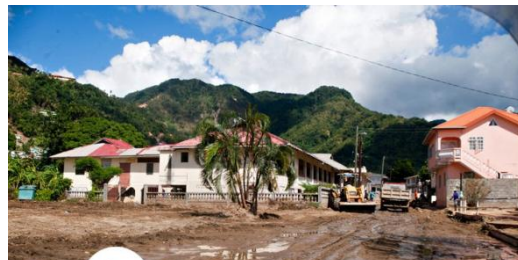
SILT DEPOSITED IN THE TOWN OF SOUFRIERE BY THE SOUFRIERE RIVER

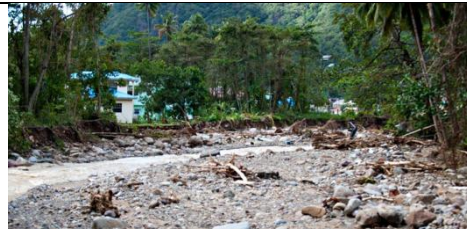
SILT AND DEBRIS IN THE MAIN CHANNEL DEPOSITED BY THE SOUFRIERE RIVER NEAR NEW DEVELOPMENT

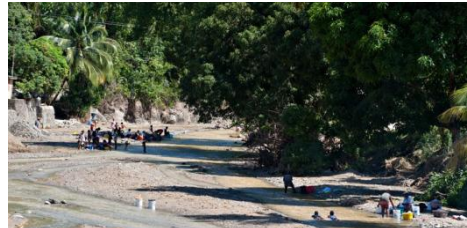
SILT DEPOSITION BY THE CANARIES RIVER NEAR MAIN BRIDGE

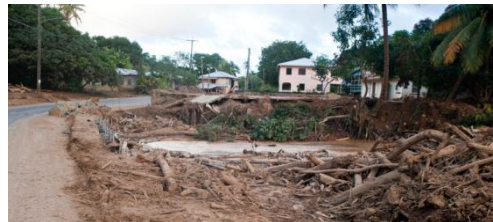
SILTATION AND DEBRIS DEPOSITION BY THE FOND DOR RIVER NEAR THE GRANDE RIVIERE BRIDGE

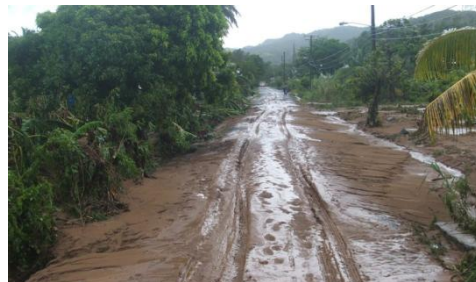
SILT DEPOSITED BY THE DENNERT RIVER NEAR MOLE ROAD

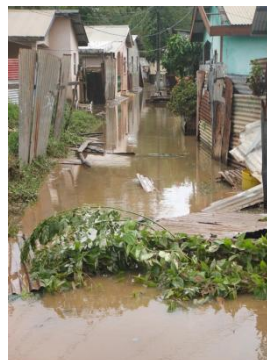
FLOODING AND SILTATION IN DENNERY OFF THE MAIN STREET

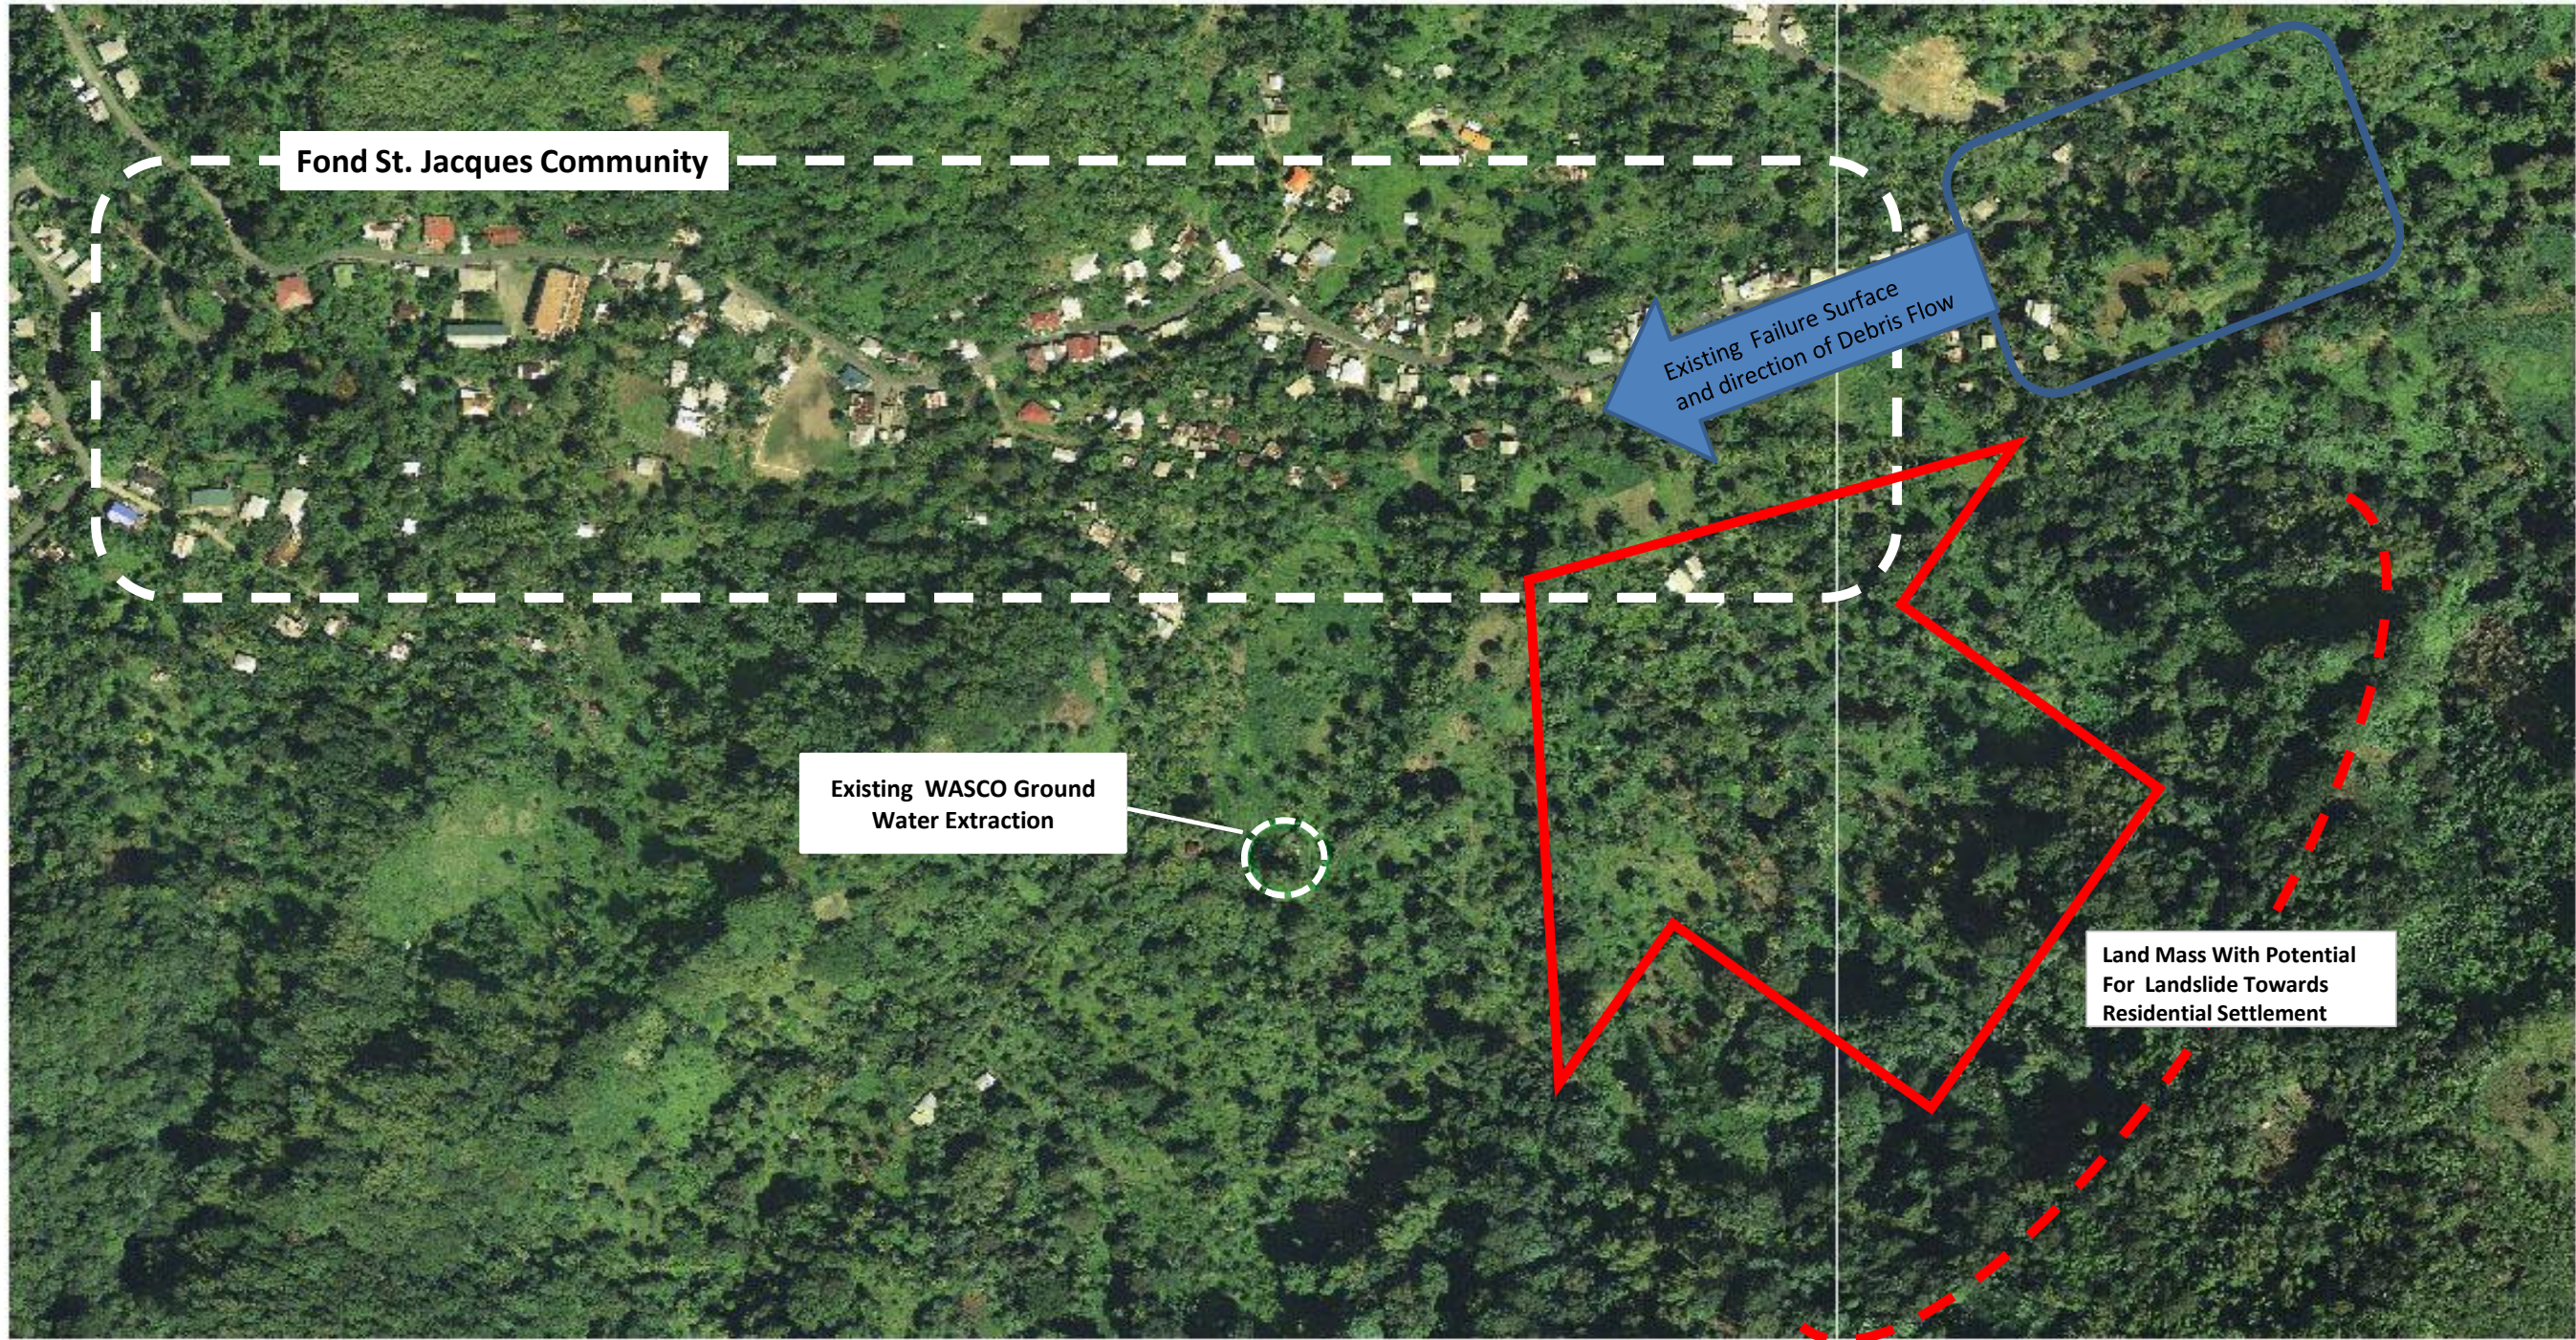
Figure 1.0 - Aerial Showing Potential Landslide Mass in Fond St. Jacques

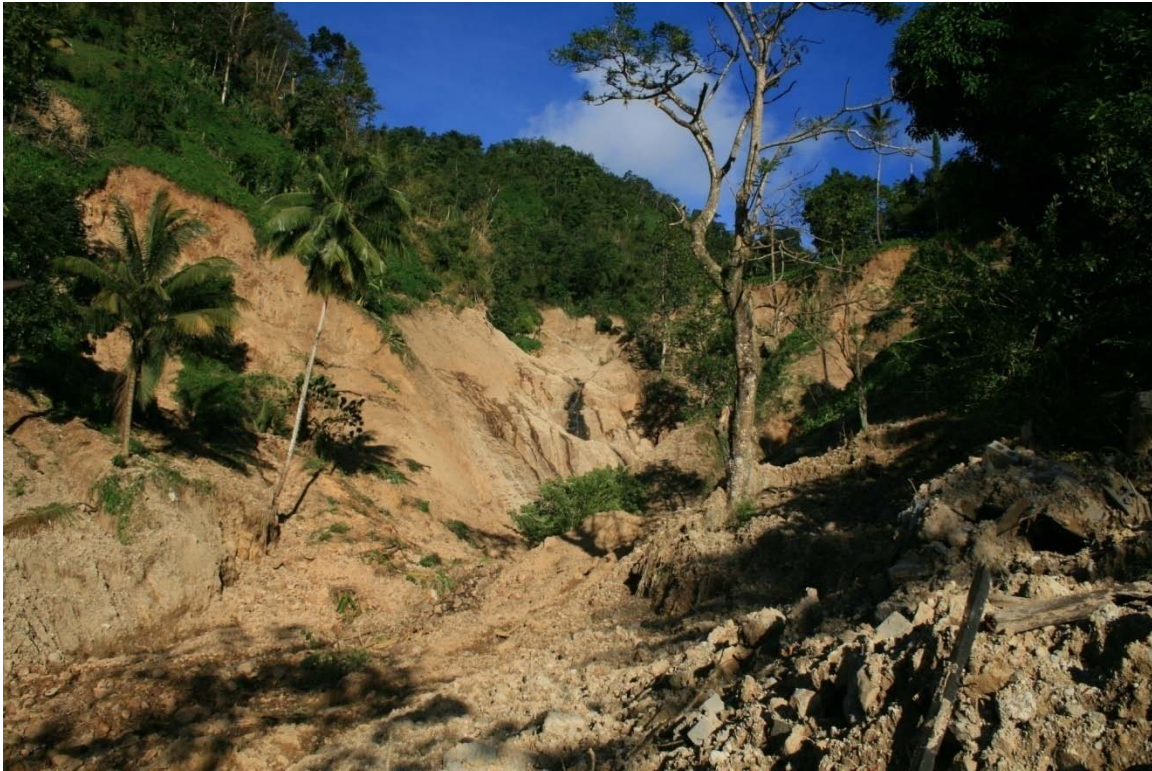
<p>Fond St. Jacques</p> <p>An extensive slide which resulted in loss of life, damage to roadway infrastructure including two bridges, significant mass wasting and the destruction of residences.</p>	<p>Very rapid debris Avalanche as a result of an increase in the pore water pressure within the subsurface soil layer.</p>	<p>There is evidence of soil creep which could lead to additional slippage at the landslide site. Significant instability may occur during or after extreme rainfall of earthquakes.</p>	<p>Short Term: Evacuate area within the slide zone. Provide adequate surface drainage and implement a river training program.</p> <p>Long Term: Redesign the landscape to improve slope stability. Evaluate the area for suitability of residential settlement. Plant trees on slopes and install relief wells for springs.</p>	<p>Development restrictions are required to limit and control activities which could affect the stability of the area.</p> <p>The potential of other landslides exists for other larger slopes surrounding the area based on a similar mechanism of failure.</p>

Photo 1.0 – Failure Surface of Fond Se Jacques Landslide

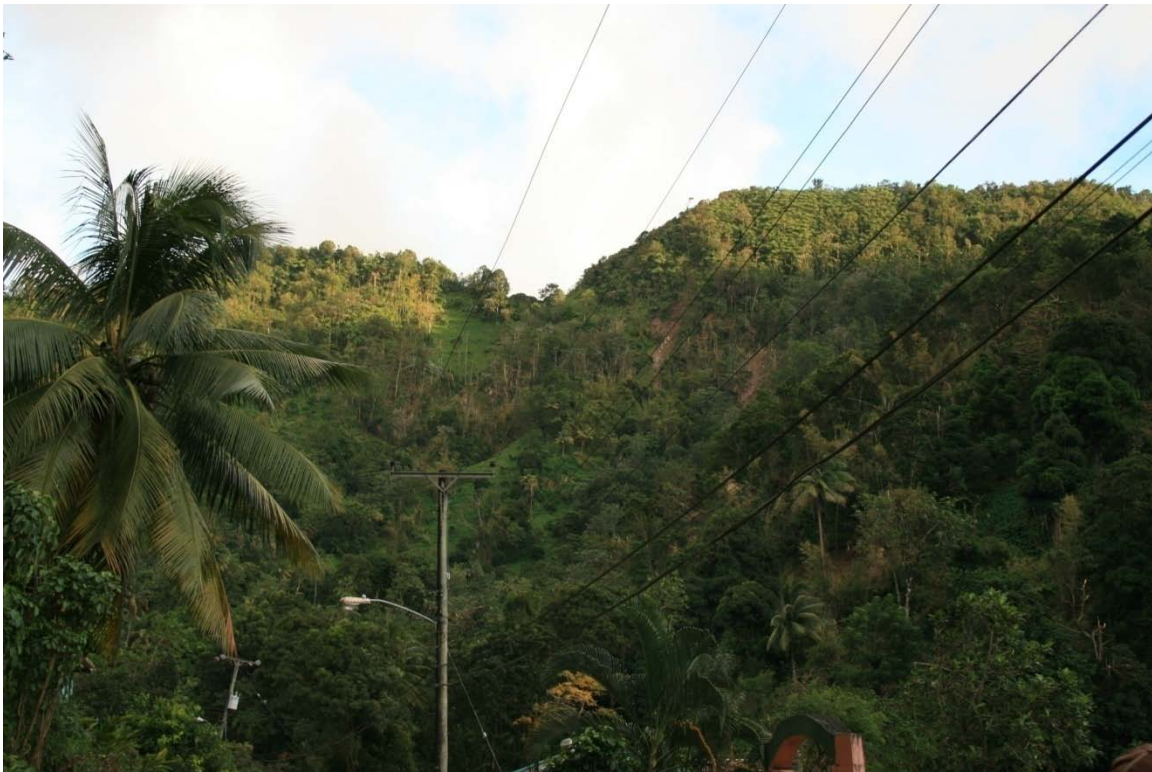
Photo 2.0 – Surrounding Hills of Fond Se Jacques with possible landslide risk to the community

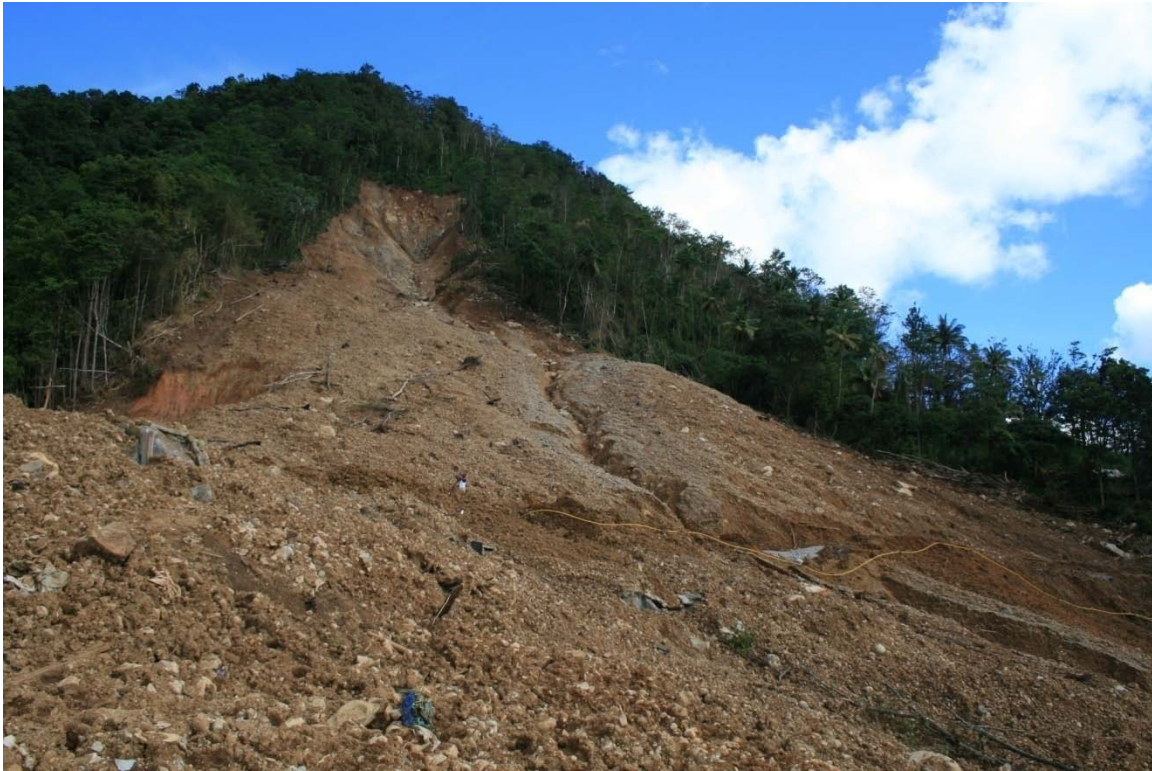
Photo 3.0 – Failure Surface of Colombette Landslide

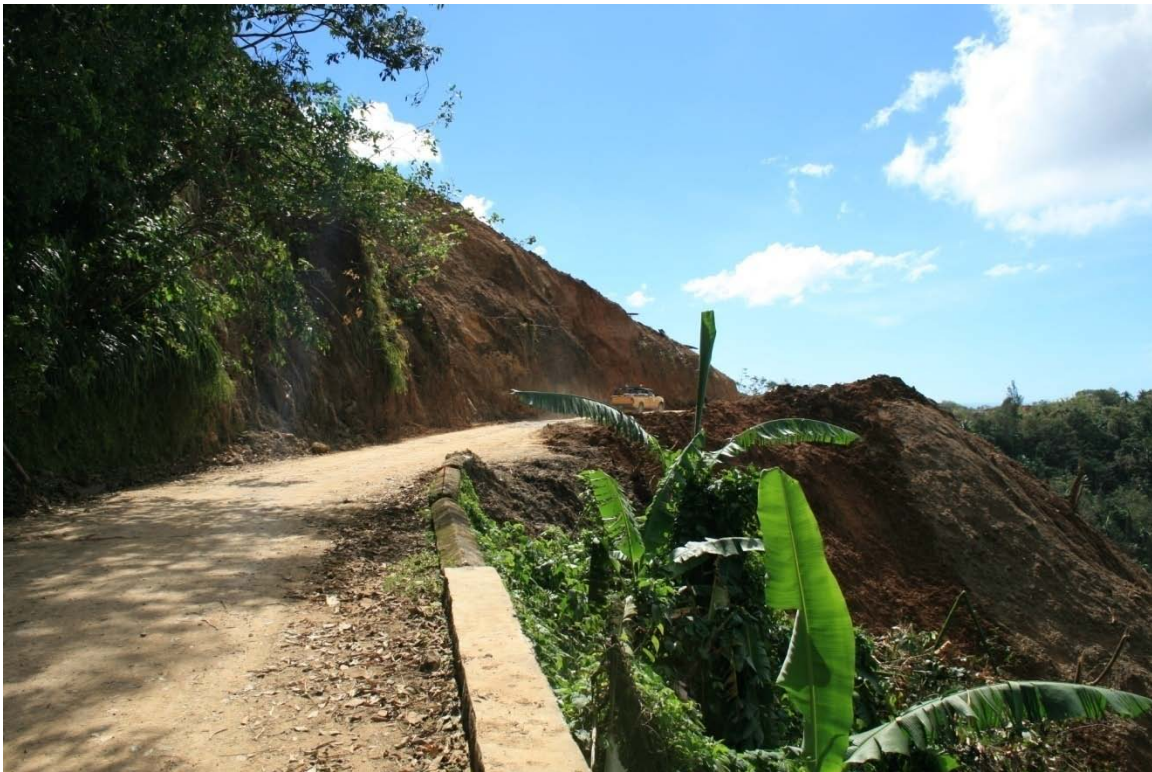
Photo 4.0 – Northern side of Colombette Landslide showing area with potential for continued debris flow

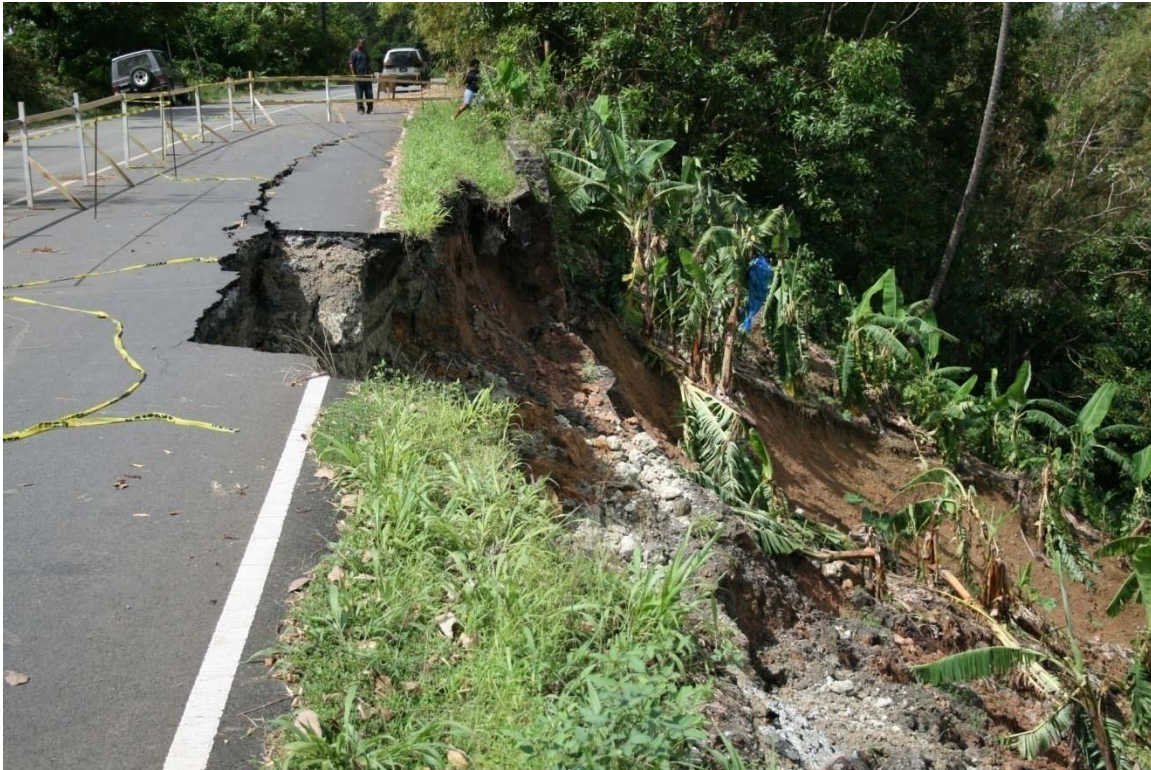
Photo 5.0 – Landslide in Barre D’Isle showing compromised roadway

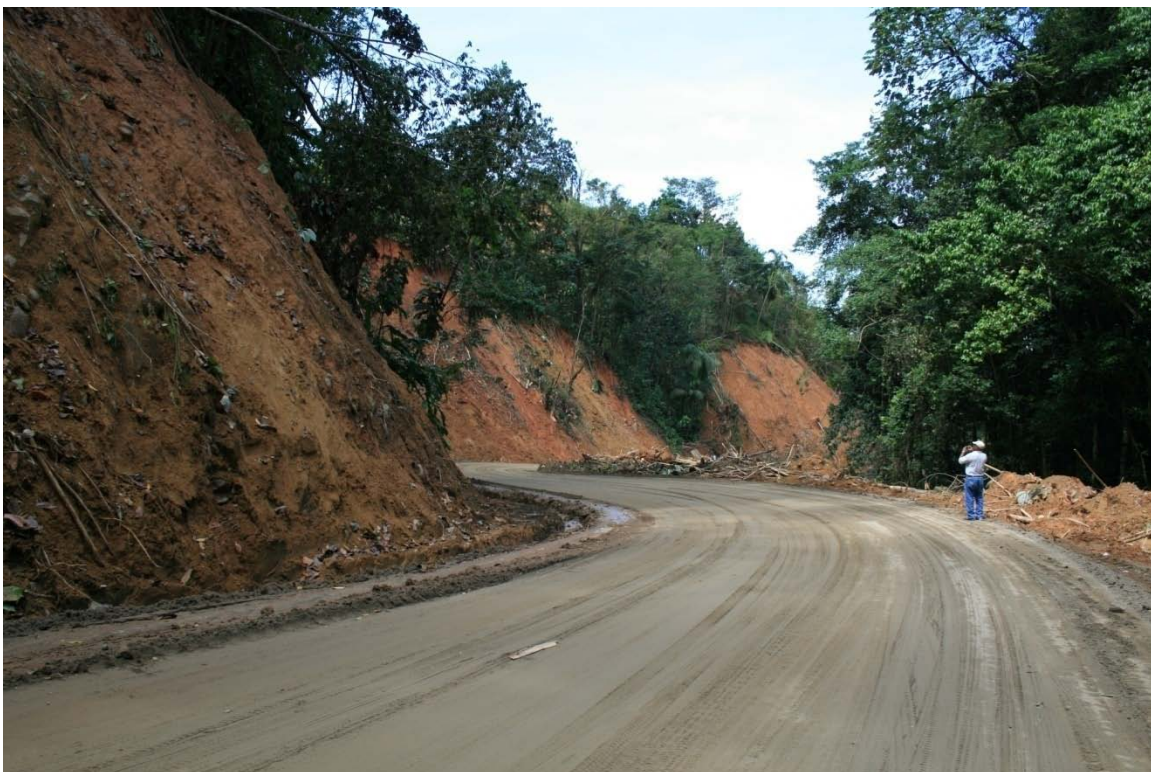
Photo 6.0 Steep slopes in Barre D’Isle Roadway which have the potential to continue sliding

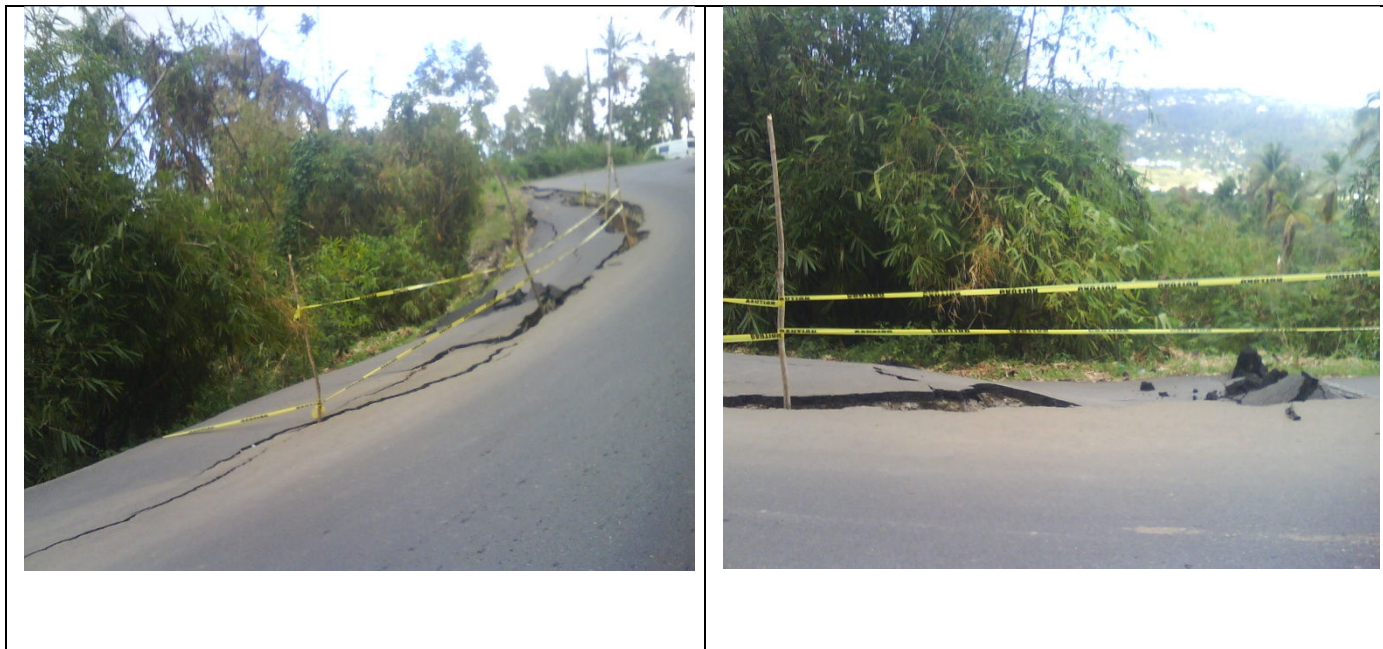
50m wide slide along downhill slope. Carriageway directly affected. Single lane traffic through this point.

There is some risk of continued failure, which would lead to further narrowing of carriageway and greater risk to road users.

Rationale/overview Like many observed this slide was a result of failure of retaining wall.	
Immediate/short term: Apart from cordoning off half the carriageway to protect the general public a short-term solution may not be economically justifiable.	Estimated COSTS
Strategic/medium-long term: Though further investigation is required to determine the exact cause and mode of failure, based on observations the proposed long-term solution may take the form of a Gabion retaining wall systems with tie-backs. And reconstruction of road pavement.	Estimated COSTS \$375,000.00

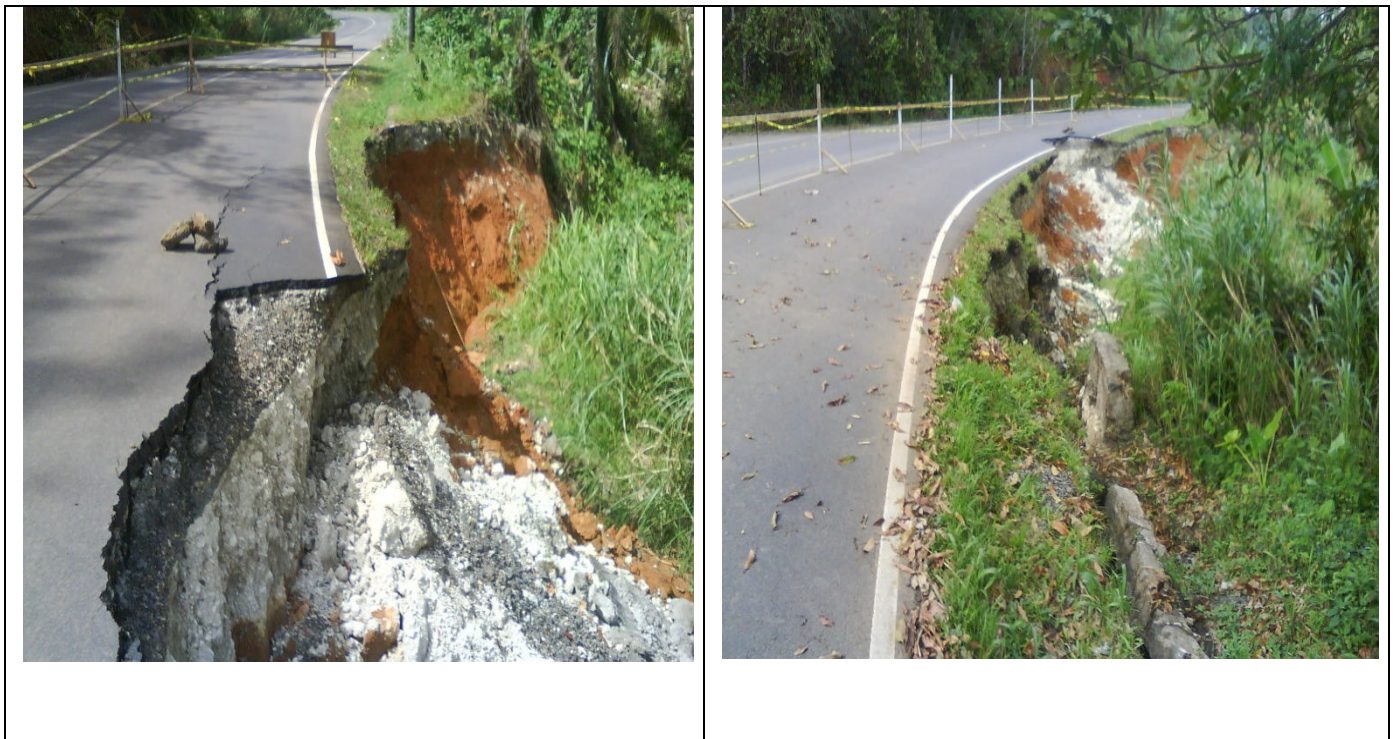
Two slide 40, 45m long, and 25m apart along the downhill slope. Carriageway directly affected in both cases. Failed masonry retaining walls.

Because these failures are along the inside of a bend forward visibility for approaching vehicles is poor and with the carriageway narrowed to one lane the potential for vehicular conflict is very high at this location.

There is also some risk of continued failure.

Strategic/medium-long term: Gabion retaining structure with reconstruction of pavement	Estimated COSTS \$800,000.00
Other information:	
Reference material used (include where document can be accessed): See attached note for <u>general</u> comments, observations, recommendations, mitigations and a list of reference material used.

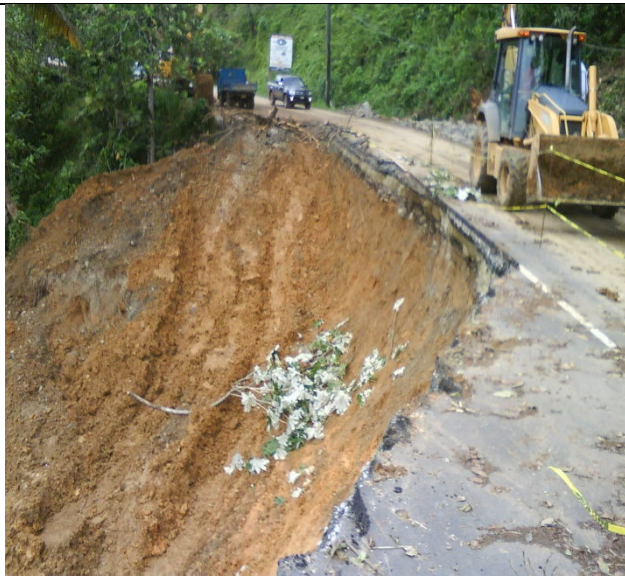
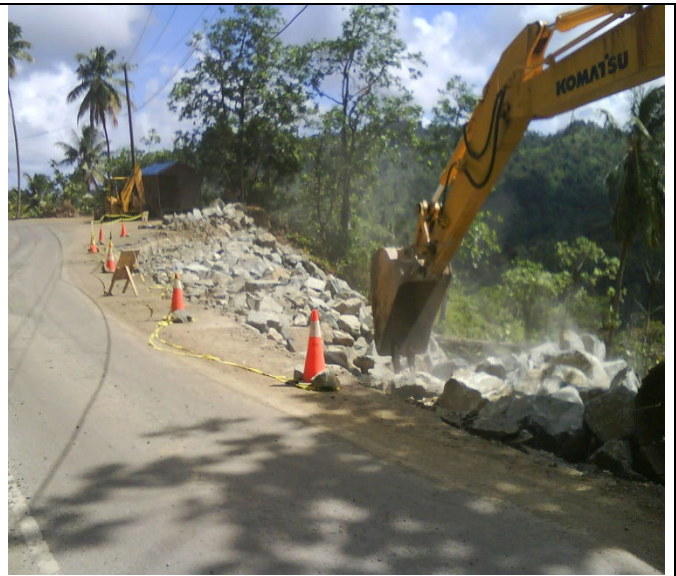
Rotational type landslide resulting in loss of half of carriageway. Length approx. 50m
Only single lane traffic possible.

Existing carriageway has been narrowed to less than half-original width. Though now widened on the uphill side by approximately 2.5m roadway is still only safe for single lane traffic. Nighttime safety will remain an issue until completely rehabilitated.

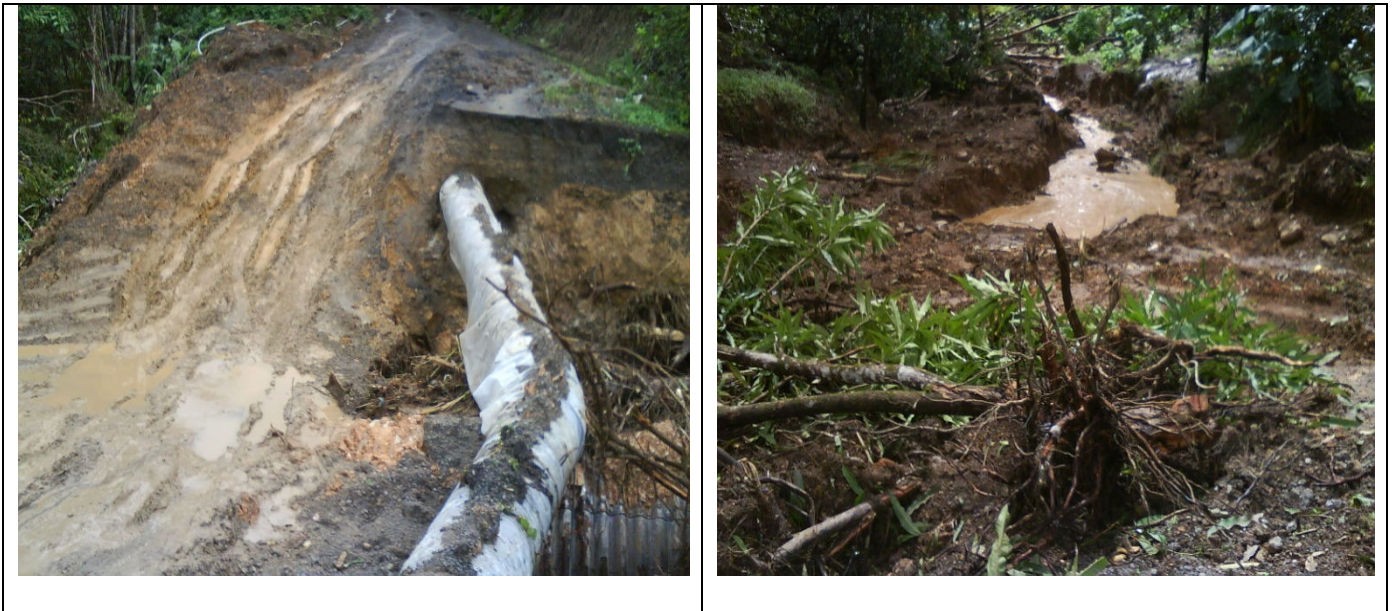
Blocked culvert damming water course and causing the erosion away of road embankment . Road is the only vehicular access to dam.

Following the storm the only access to the dam was via helicopter . It is important to insure vehicular access to this vital national asset.

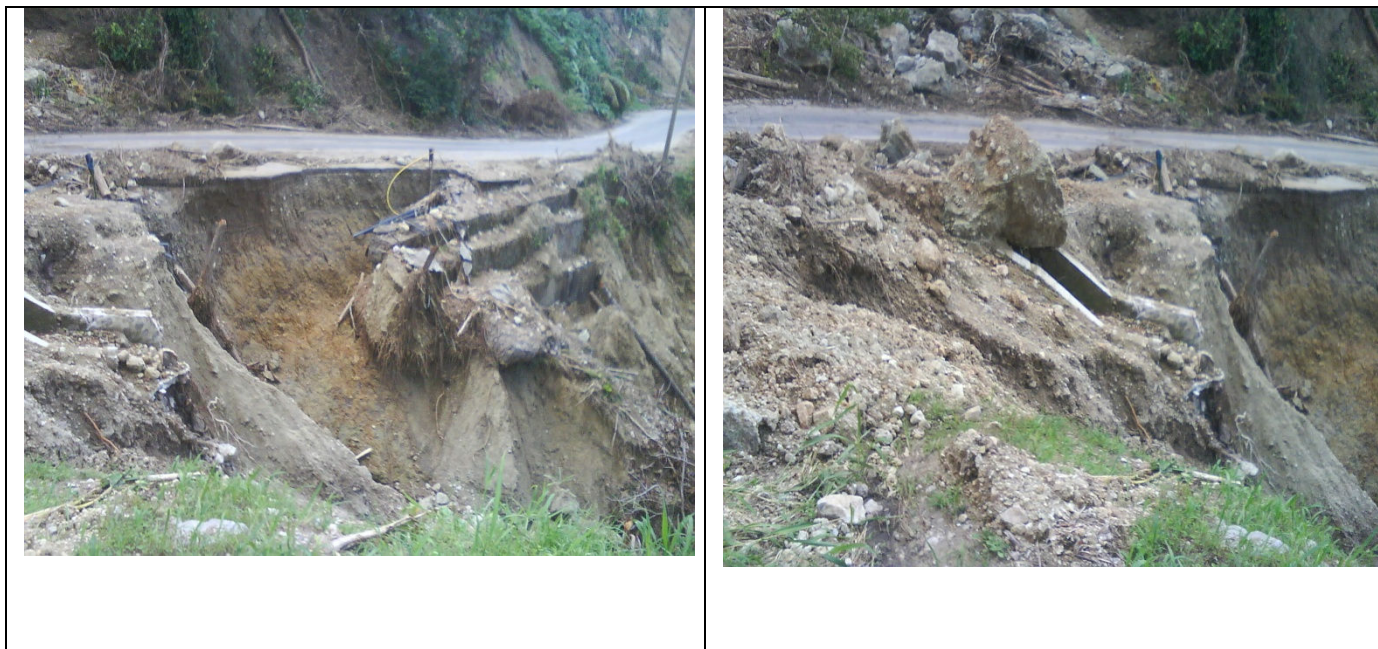
Inadequate and blocked culverts resulting in erosion on downhill slope and undermining of gabion retaining structure and roadway.

Direct and eminent freight to carriageway if not addressed short-term.

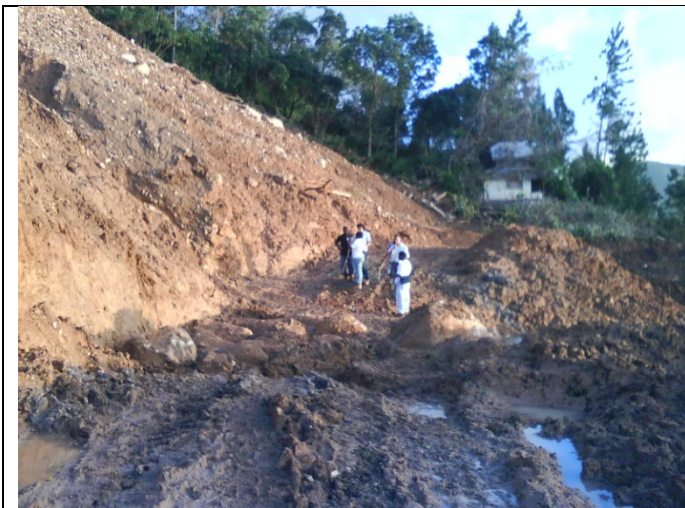
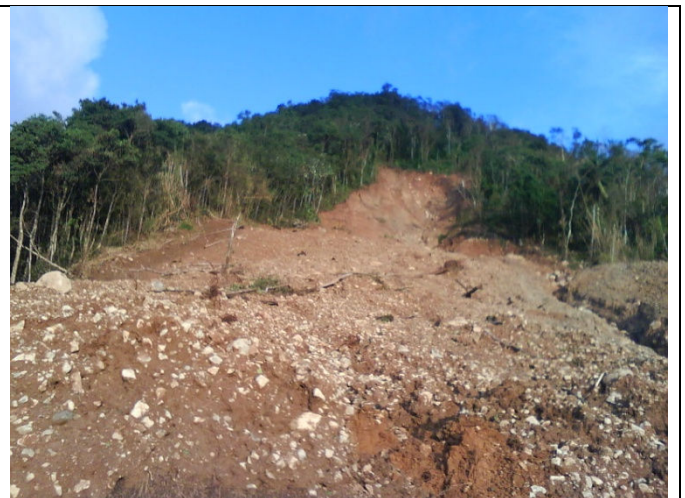
Crown of slide approx. 200m above roadway. Finale position of toe approx. 300m below.

As of 10th November it was observed that roadway had been cleared for single lane traffic. Significant risk to road users still exist, loose slide material on slope above road has now been made more unstable again with the removal of material to clear road.

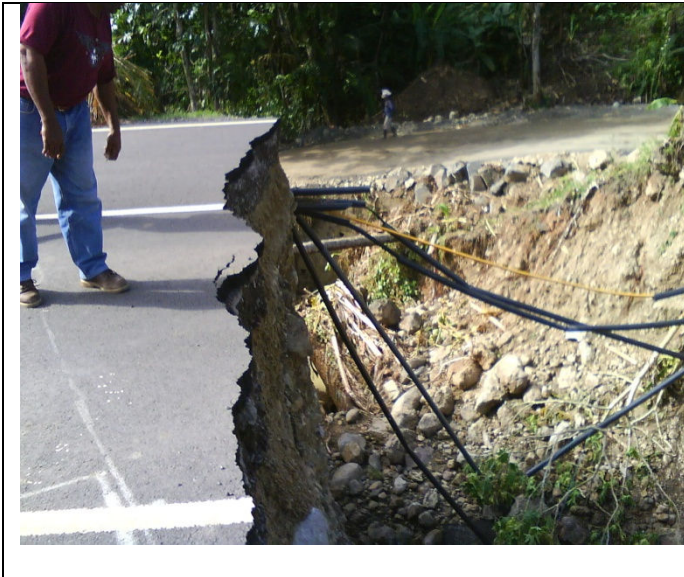
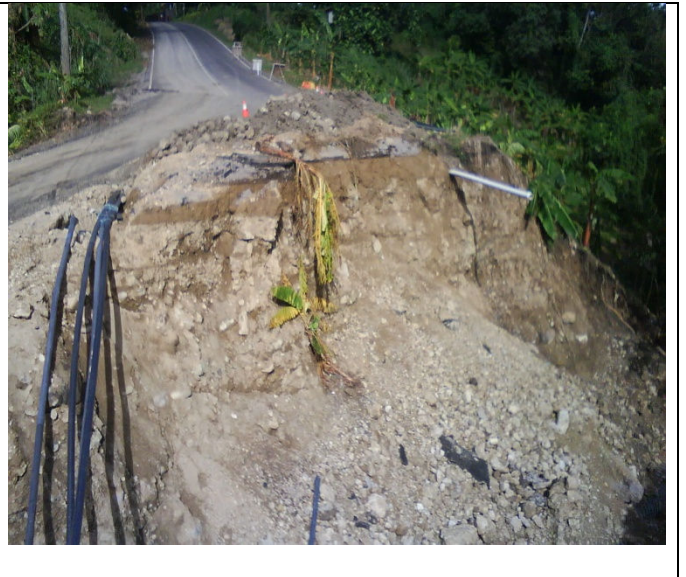
Culvert blockage leading to damming of watercourse and erosion of road embankment.
Existing failed structure is corrugated steel pipe approx. diameter 2m.

With this failure and others along major arterial roads travel time and wear and tear on vehicles is significantly increased with the consequent impact on economic activity and vehicle operating cost.

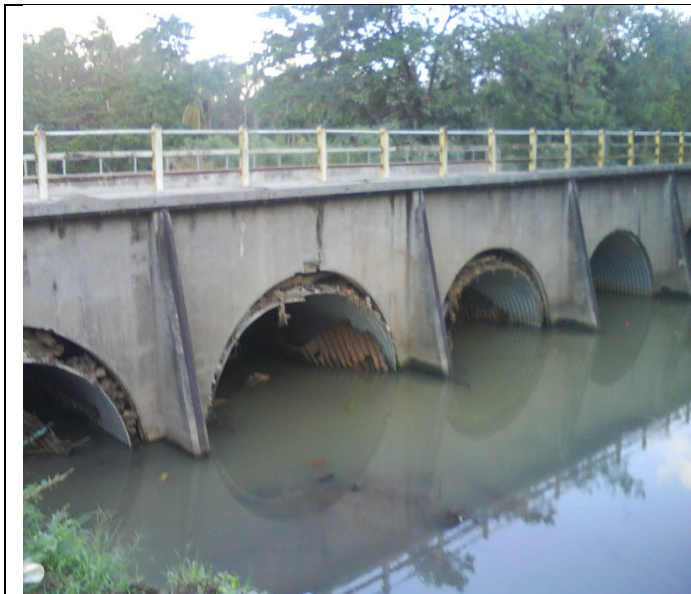
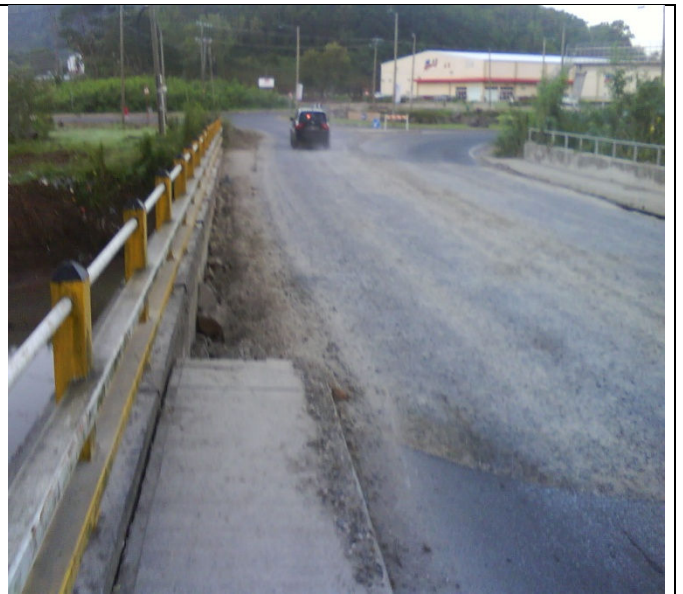
Damaged roadway/bridge structure due to the blockage corrugated steel barrels and consequent damming of river overtopping roadway. Scour and erosion of fill material between barrels is evident voids may be present in structure.

Economic activity disruption on this very heavily traffics route, which links the commercial centre of Castries to the rapidly developing and highly touristic north. Interim measure put in place

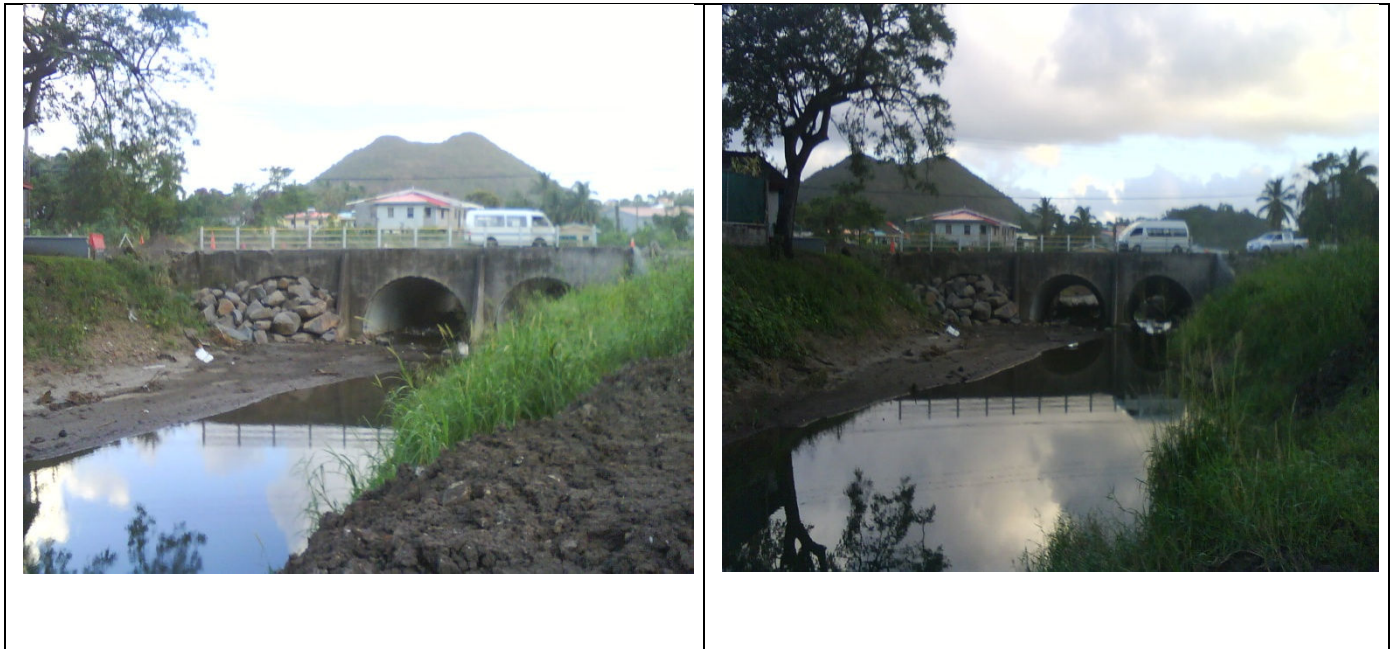
Damage caused to roadway/bridge structure due to blockage of three (3) corrugated steel barrels and consequent damming of river at that point. One of the barrels collapsed and now filled with boulders. Remaining two (2) barrels partially collapsed on downstream side.

The existing condition of barrels means that the hydraulic capacity of structure is severely reduced. Although an interim measure has been put in place (i.e. RC pavement slab) a significant risk of collapse and additional traffic disruption remain. Economic activity would be further hindered on this already very heavily trafficked route which links the commercial centre of Castries to the rapidly developing and highly touristic north.

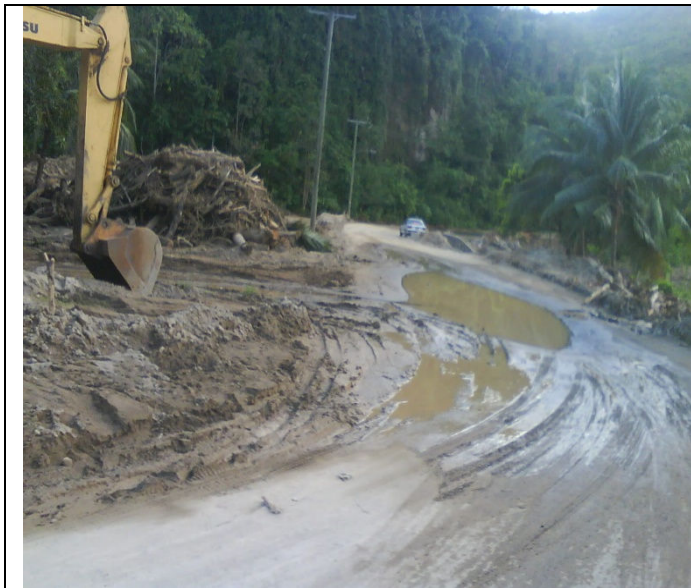
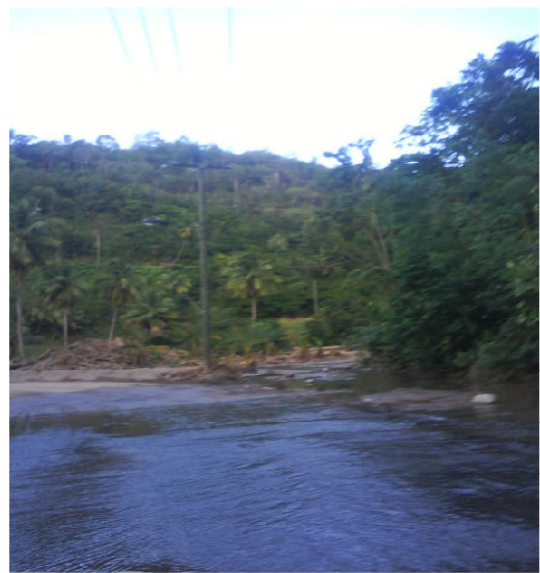
Corrugated steel single barrel culvert blocked by debris damming river resulting in roadway being overtopped damaging via scour downstream side of carriageway and drainage structure itself. River coarse diverted and continues to overtop carriageway as of 14 Oct.

Water from river on carriageway
