**REPORT OF THE  
EASTERN  
CARIBBEAN  
DONOR GROUP  
FOR DISASTER  
MANAGEMENT  
RAPID NEEDS  
ASSESSMENT  
TEAM TO SAINT  
LUCIA  
FOLLOWING  
THE IMPACT OF  
HURRICANE  
TOMAS**

7th November 2010

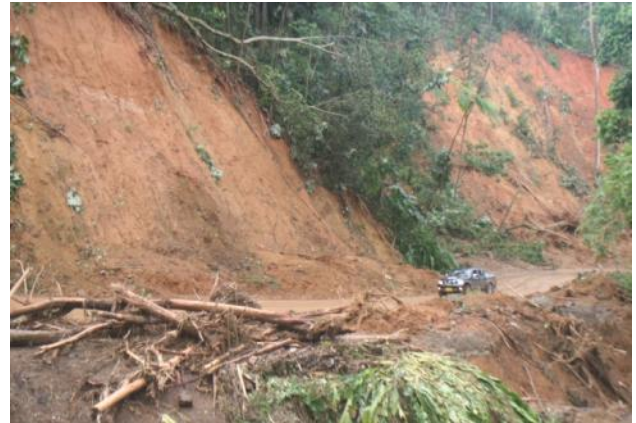
Figure 1: Landslide impacting the road infrastructure

Repairs to the extensive damage to the road network and bridges are underway. However, debris collected at bridges must be removed and embankments strengthened to reduce a high risk of further potentially catastrophic, flooding. In the agriculture sector, early clearance of fields will allow re-planting of crops. Detailed risk assessments and a strategy are needed to stabilize weakened slopes and avoid further landslides.

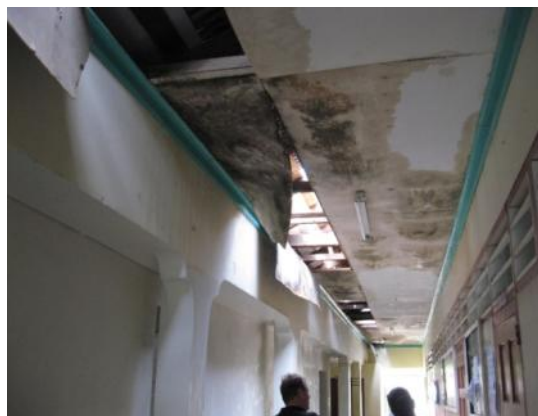
Figure 3: Evidence of roof damage at Soufriere Hospital

Most of the eight health facilities which were affected have been restored. The Dennery Hospital has however been decommissioned due to the damages. Soufriere hospital is still limited to pedestrian access, with the destruction of the main road entrance, and the Pediatric wing at Victoria Hospital needs to be re-roofed.

Leaking: 2 (Victoria & Soufriere) Issues with Soufriere hospital roof and laundry area addressed by the UK. Primary issue now is restoring road access.

- UK: supplied generator to shelter in Fond St. Jacques (refer to RNAT report 1 of yesterday – access by road now re-established to this community) and petrol station in Soufriere, bottled water & search and rescue in Fond St. Jacques, Soufriere hospital repairs (roof and laundry room repairs); 16000 puritabs and 300 tonnes.

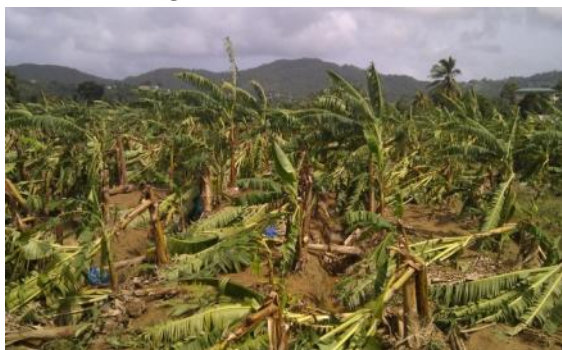
Figure 4: Damaged banana crops in Roseau Valley

The agricultural sector sustained substantial damage during the passage of Hurricane Tomas with the banana industry being severely affected through toppling, flooding and sedimentation. Preliminary estimates of damage to the banana industry range between 80% and 90% with a potential weekly income loss up to EC\$2.0 million over the next six month period. The need for replanting, drainage of fields and the reconstruction of irrigation systems and boxing sheds are evident.

1. Cleaning of fields and irrigation systems
2. Drainage of fields and the reconstruction of irrigation systems
3. Support for replanting and production (tools, seeds and boxing sheds)
4. Rebuilding / repair of access roads, sheds and other structures

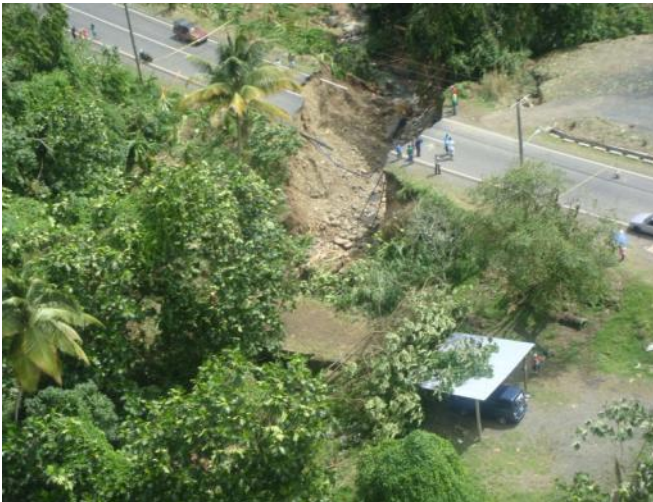
Figure 5: Destroyed road infrastructure

Most of the destruction is not the result of wind or flooding but from subsequent landslides which have cut roads, destroyed bridges and washed away entire river banks deep inside. The impact on the road system is variable with blockage by debris; erosion; and compromise loss of retaining structures (see image). Infrastructure is therefore a major concern with rehabilitation being a mammoth task. Most adversely affected areas are in the south west, with the greatest impact being in the Soufrière district. Additionally the disruption of the access to the tourist sites around Soufriere impacts the livelihoods of the local communities.

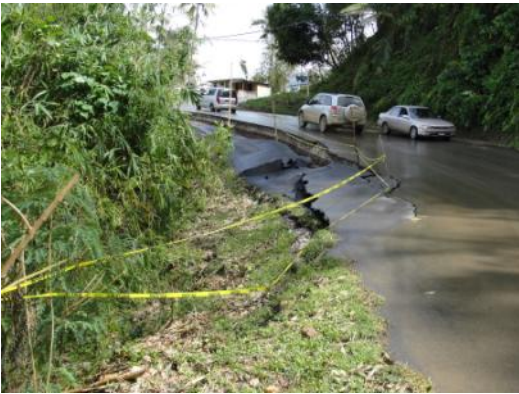
Figure 6: Road failure near LUCELEC

The landslides associated with Hurricane Tomas have impacted and continue to threaten the stability of some of the roads. As shown in the highway near LUCELEC, a significant road failure is evident. The initiation of road failure is also observed at another location along the road. However, no warnings were provided for the site where the failure was developing. These situations pose a risk to vehicular traffic and pedestrians, especially heavy vehicular traffic. It is likely that the frequency of heavy vehicular traffic on/along the highways

will increase significantly in the near future due to the clean-up operations.

- The landslides associated with Hurricane Tomas impact the stability of some of the roads. Sections of the highway near LUCELEC heading towards the east coast. One major failure, taking up half of the highway was observed. A second failure, 100 to 200 metres away was beginning to initiate. A portion of one side of the highway was cordoned (along the line of the failure) to vehicular traffic. No warnings were provided for the second site where the failure was developing. These two situations pose a risk to vehicular traffic and pedestrians, especially heavy vehicular traffic. It is likely that the frequency of heavy vehicular traffic on this highway and along other highways will increase significantly in the near future due to the cleanup operations. A road safety monitoring programme should be initiated, if not already in place, to identify those portions of the road network that may fail under various vehicular loads.

3. It is highly recommended that geotechnical advice be sought to provide guidance related to stabilization of the current environment and long term actions to prevent a recurrence of this situation given that the combination of climate change and increasing climate variability may provide similar extreme weather events in the future.

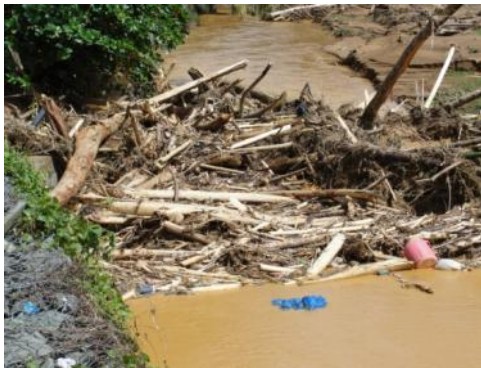
Figure 8: Debris in river

The massive amount of flooding coupled with the wind damage resulted in a significant amount of material being deposited in the river channels. **It is important that much of this material that is blocking the channels be removed as quickly as possible to prevent further flooding from smaller future events.**

5. Clearance of debris around bridges. There is a danger of collapse and life threatening flash floods. This should be accompanied by landslide assessments and slope stabilization. This should also involve a debris management plan.
